Manhole Inspection Summary

Manhole # S4300_040MH

Insp Date: **4/2/07 11:29 AM**

Location Address: **1301 25TH ST**

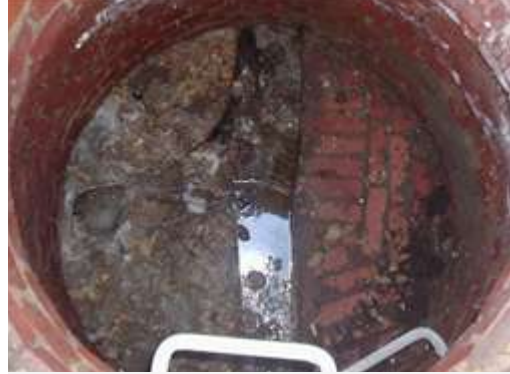
Top View

Barrel infiltration. Evidence of surcharge - Bench debris. Channel debris.

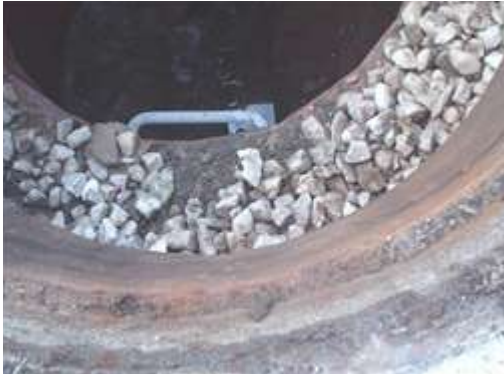
Defect

Frame leaks. Frame offset. Adjustment deterioration and infiltration.

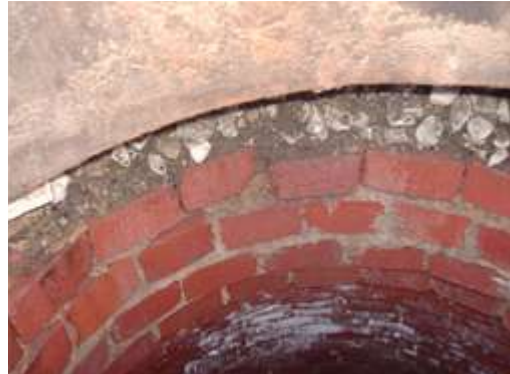
Defect

Frame leaks. Adjustment deterioration and infiltration. Corbel infiltration.

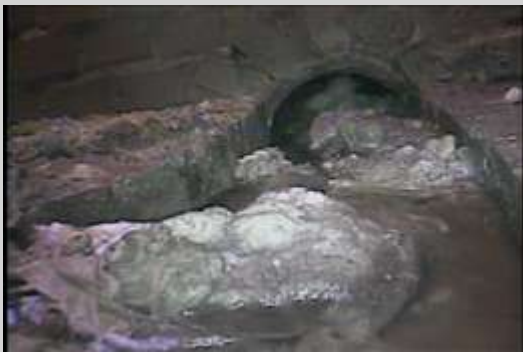
8 in. Circular Gravity Sewer Pipe Out @ 12 O'Clock

Deposits: ☐ None ☒ **Mud** ☐ Sludge ☒ **Debris** ☐ Grease

Silt Depth: **5** (in.) Deposits Extent: **Heavy**

Infiltration: **Evidence** Pipe Seal Cond: **Cracked**

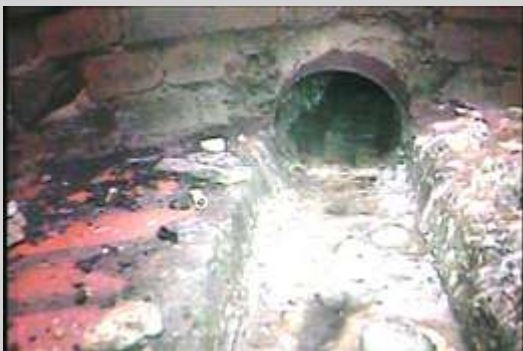
6 in. Circular Gravity Sewer Pipe In @ 6 O'Clock

Barrel deterioration and infiltration.

Deposits: ☐ None ☒ **Mud** ☐ Sludge ☐ **Debris** ☒ **Grease**

Silt Depth: **0.5** (in.) Deposits Extent: **Light**

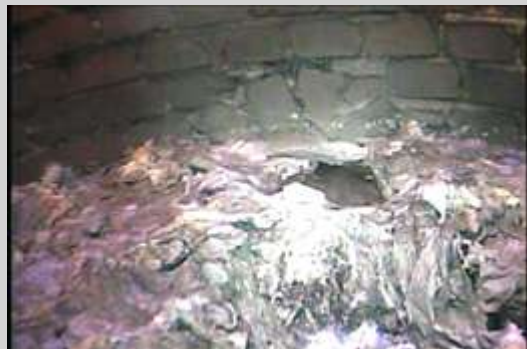
6 in. Circular Gravity Sewer

Pipe In @ 9 O'Clock

Deposits: ☐ None ☒ **Mud** ☐ Sludge ☒ **Debris** ☐ Grease

Silt Depth: **4** (in.) Deposits Extent: **Heavy**
